Manhole Inspection Summary

Manhole # S25G__043MH

Insp Date: **4/2/08 10:00 AM**

Location Address: **1221 BALTIMORE ST**

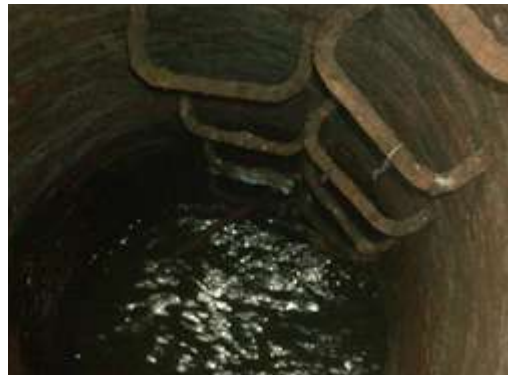
Defect 3

Count: **13** Missing: **0** ☒ **Corroded**

☒ **Evidence Of Surcharge** Depth: **10** (ft.) ☐ Active Surcharge Present

CORRODED STEPS WITH
SURCHARGE EVIDENCE PRESENT

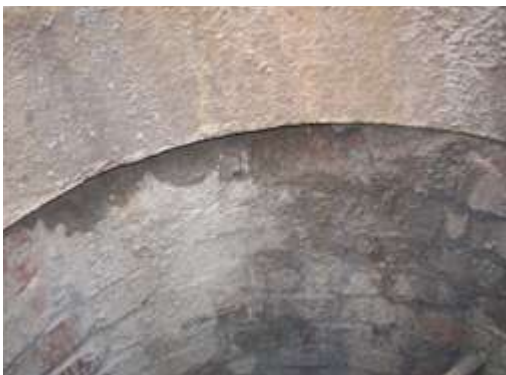
Defect 2

Condition: ☐ Sound ☐ Cracked ☐ Root Intrusion ☐ Loose Brick ☒ **Deteriorated**

Infiltration: ☐ None ☒ **Joint** ☐ Cracks ☐ Mortar ☐ Roots ☐ Wall

DETERIORATED CORBEL WITH
INFILTRATION EVIDENCE AT THE
JOINT

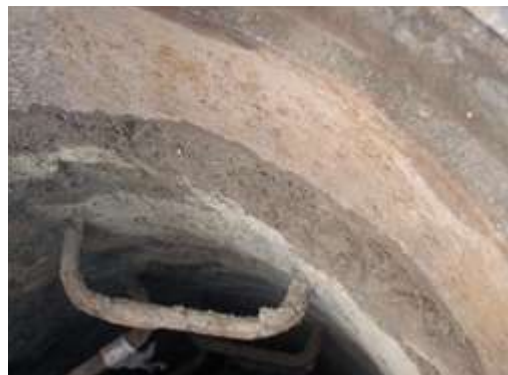
Defect 1

Offset: **1** (in.)

FRAME OFFSET

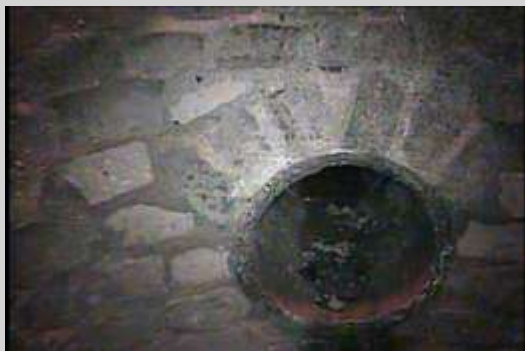
12 O'Clock Inflow

Pipe Height: **8.4** (in.) Direct (Angled)
Pipe Material: **Clay** ☐ Pipe Lined
Invert Depth: **12.21** (ft.) Flow Characteristics: **None**
Deposits: ☐ None ☐ Mud ☒ Sludge ☒ Debris ☒ Grease
Silt Depth: **2** (in.) Deposits Extent: **Heavy**
Infiltration: **None** Pipe Seal Cond: **Sound**

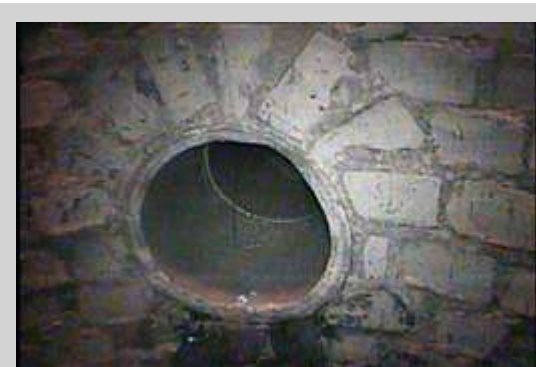
9 O'Clock Inflow

Deposits: ☐ None ☐ Mud ☒ ~~Sludgy~~ ☒ Debris ☒ Grease

Silt Depth: **8** (in.) Deposits Extent: **Heavy**
